## Report for Maintenance Air Cooled Chiller Power Ciat 2800X

In this report, the maintenance of the chiller ciat to feed the cooling capacity of the presidency of Al-Nahrain University and the student club buildings was achieved. The chiller ciat was repaired and operated by using the planning study for the maintenance and complete all faults that leads to stop the chiller from working. The results for repairing are very good and the chilled water temperature is (7°C) to feed the air handling units, which gives the cold air inside the building to all facilities such as (offices, and hallways). According to the maintenance of the chiller ciat was utilized the best material and with cheap prices, which were brought from the local markets, such as: gat valve to open/close the chilled water that exit from the evaporator to the pumps, air vents, filters, ball bearing type (NSK-Poland) and it size was (6005Z). For repairing the package unit of the computerize center in the student club building was invented a new method that leads to cool this place with facilities such as (offices, and hallways). A better performance was achieved for the output chilled water from the chiller and the a

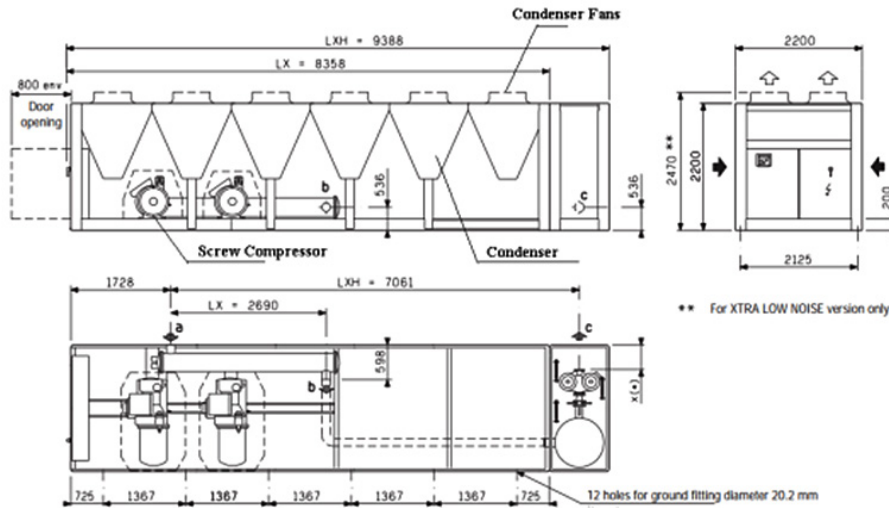
**Fig. 1: Chiller ciat layout with all specifications<sup>7</sup>**

Chiller ciat layout to demonstrate the chiller details specifications as shown in figure (1), this figure

exhibit the detail about the chiller 2800 X with its dimension and the body of the chiller that consist of

the screw compressor, condenser fans, condensers, and all connected pipes.<sup>4</sup>

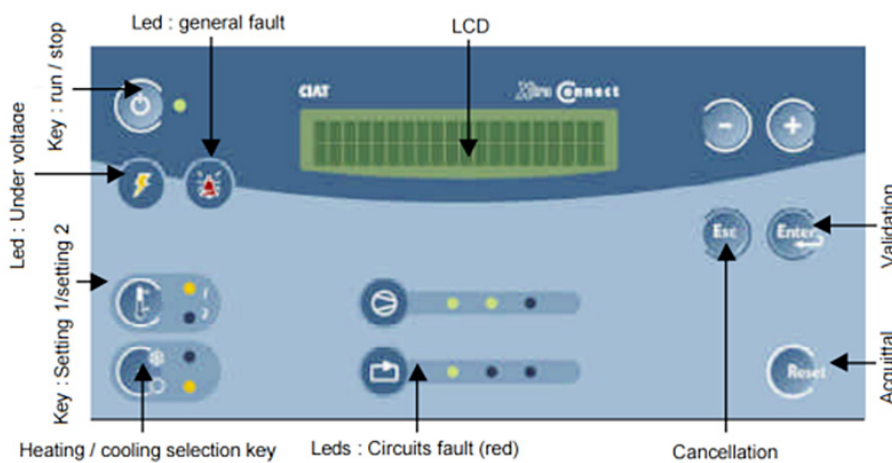
**Fig. 2: Console screen for chiller ciat<sup>7</sup>**

Chiller is operated by using the console screen and the buttons which included with the screen as shown in the figure (2), all these buttons are used to operate and setting of the chiller. The cooling fluid was Freon R-134A as a refrigerant to cool the water in the evaporator. This screen consists of LCD (2 lines of 20 characters) to let the available free contacts inputs information as: flow rate sensor, set point 1 or 2 selection for the circuit running, general

fault, pump control, load shedding for compressors, and emergency cut. The screen is worked as a remote control for chiller and its electrical current about (4-20 mA). Outputs information as: general fault per circuit, fault information contact, hot gas discharge temperature, superheating and de-superheating temperature, antifreeze temperature fault, and fans fault.<sup>6</sup>

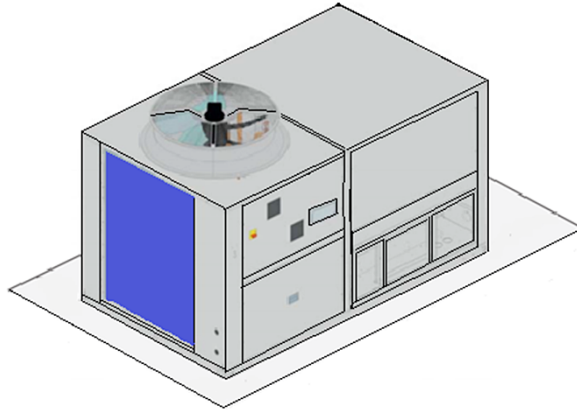
**Fig. 3: Package chiller picture RPF 180U<sup>8</sup>**

Package ciat RPF 180U is shown in figure (3), 45.1 kW, 12.5 tons, and 5000 cfm (ft<sup>3</sup>/m). The

rooftop package unit is consisted of a centrifugal fan to cool the condenser and axial fan to supply the

cool air which enters to the offices rooms, hermetic scroll compressors, control board, condenser coil and evaporator coil contains a Freon R-410A as a

working refrigerant to cool the air that enters to the evaporator.<sup>7</sup>

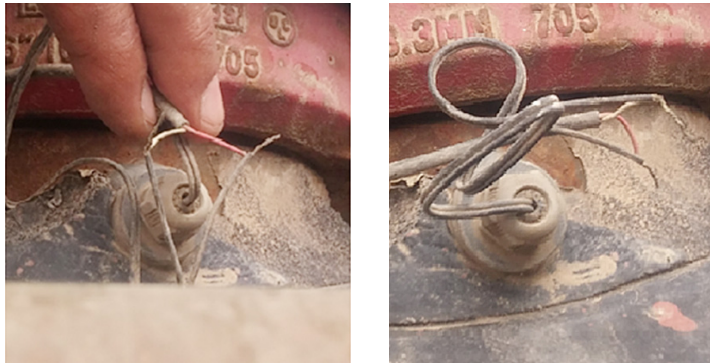
**Fig. 4: Sensor wire before repaired**

to exhibit the active fault which caused by these restrictions throughout the sensors that lead to stop the chiller for working. These sensors are the main part of the chiller, but any fault

in them will cause a disturbance in the control inside the microcontroller. Figure (4) is the real picture was taken from the chiller body before repair these sensors.<sup>7</sup>

- In this fault contains several sensors were repaired by using some procedures as: the outdoor air temperature sensor wire, hot air temperature sensor wire for inlet and outlet of the condenser, discharge temperature sensor wire for the compressor to measure the superheating of Freon, suction temperature sensor wire for the compressor to measure the suction line temperature, inlet temperature sensor wire for the evaporator to measure the inlet water temperature of evaporator, outlet temperature sensor wire for the evaporator to measure the outlet water temperature of evaporator, all these sensors were cut down which lead to a short circuit occurred. For that reason, the fault is displayed upon the screen. Each sensor was repaired by connecting the wires and adjusts the resistance of the sensor to a set point as shown in the catalog. The repaired sensors were tested successfully in the chiller for circuit 1 and 2 as shown in figure (4)

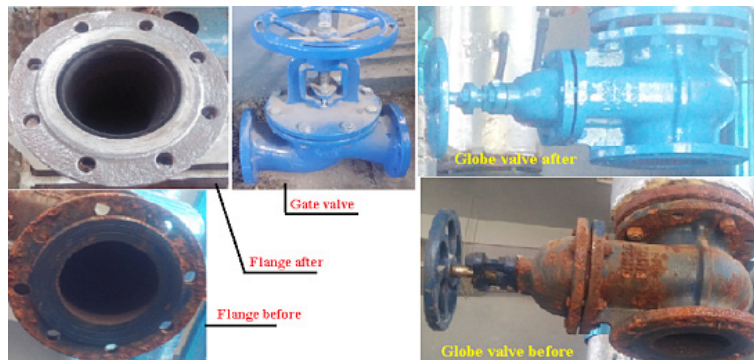
**Fig. 6: Accessories for water line before and after repairs**

- The pipe water line fault was caused by oxidation the gate valves because of water flow rate and no body maintained it through the season, the gate valve was replaced as a solution for this case by another new one and fixed with the main pipeline. The globe valve

was opened and cleaned by a brush was fixed inside a rotor to remove all the oxidation from it by using sulfuric acid ( $H_2SO_4$ ) as an assistant factor to get rid of the surface oxidation, then washed by water and polished by a brush. The globe valve was coated by an anti-rust and blue color respectively to keep it from the oxidation. Flanges of the flexible joint also cleaned by sulfuric acid to remove the oxidation, then coated by an anti-rust and blue color to protect from the oxidation as shown in figure (6). All these accessories were fixed with the main pipeline to the pumps. The piping system was filled with water from the RO system to filtrate the water to the chiller which will be ready for the work.
